COLONIE DAM

INVENTORY NO. N.Y. 204

PHASE I INSPECTION REPORT NATIONAL DAM SAFETY PROGRAM

AUGUST, 1978

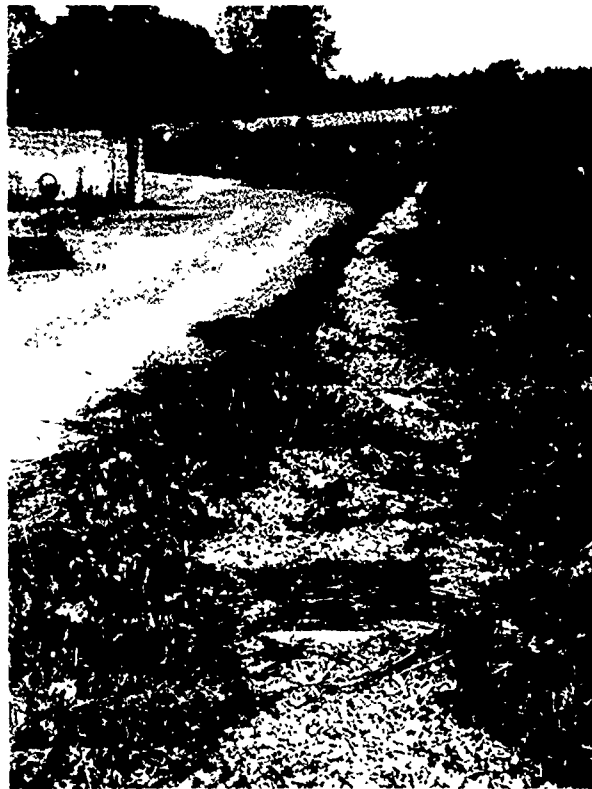
Toe Drain Looking North

good condition of toe drain

2 to 3 gpm

- c. Extend the toe drain toward the south abutment to collect the water which was ponded.
- d. The gate operating structure and appurtenant valves should be inspected periodically and systematically repaired as required.
- e. Vegetative growth on the embankment and along the spillway walls should be removed.
- f. Animal burrows on the downstream face should be backfilled and areas seeded.
- g. Spillway walls should be repaired and expansion joints in the spillway slab recaulked.

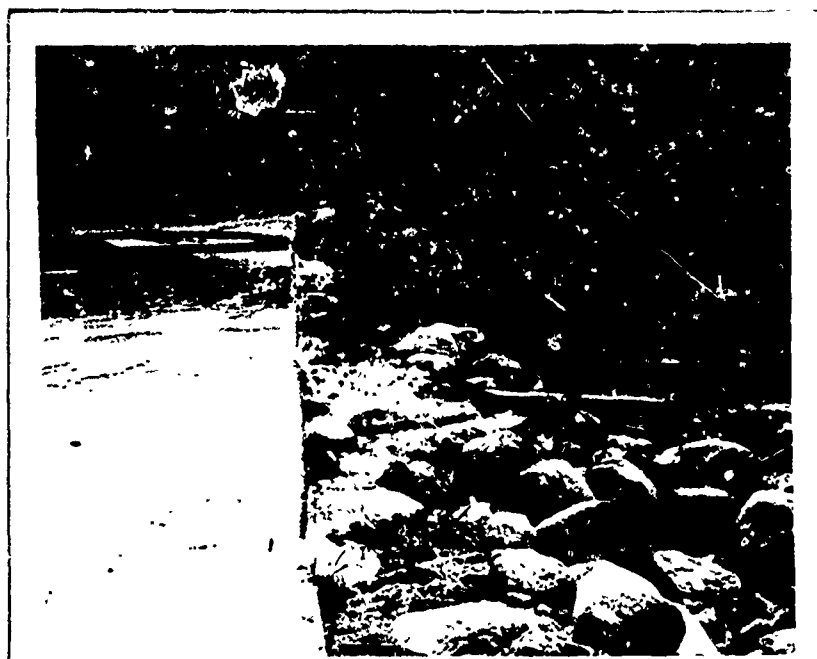
(5) Extensive erosion of the channel bed and banks was observed such that the end of the spillway was being undermined and the easily eroded silty, clay subsoil was exposed. Intermittent

Tailrace Channel Looking South

d. Condition of Tail race channel Some debris, recently eroded
channel exposing silty clay base of stream, some logs used
to retain soil around 24" CIP water supply main, logs were
being breached on north end Due to loss of riprap spillway
is beginning to be undermined

The stability of the spillway should be investigated immediately. Monitoring of observed seepage should commence immediately. Rehabilitation of the downstream channel should be completed before the next spring run-off period commences.
